International Journal of Civil Engineering and Geo-Environment

PRELIMINARY DAMAGE ASSESSMENT DUE TO 2015 RANAU EARTHQUAKE

T. A. Majid^{1*}, A. Adnan², M. I. Adiyanto³, M. Z. Ramli², T. C. Ghuan⁴

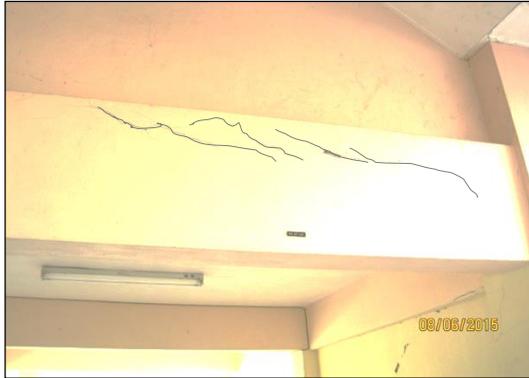
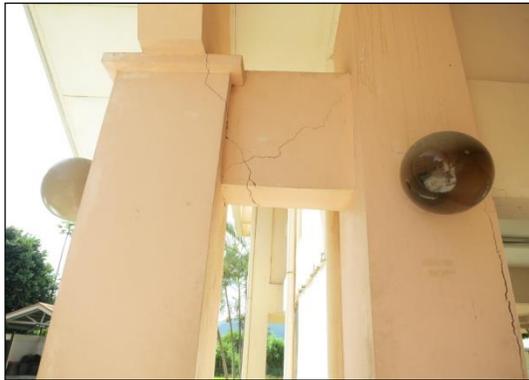
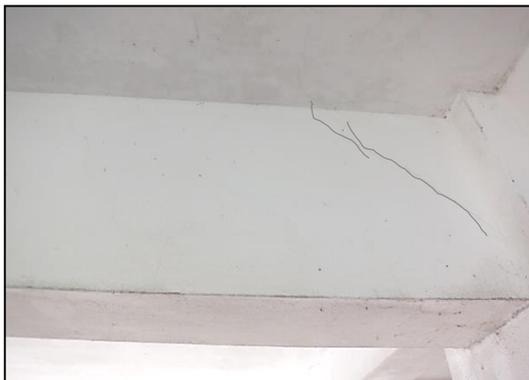
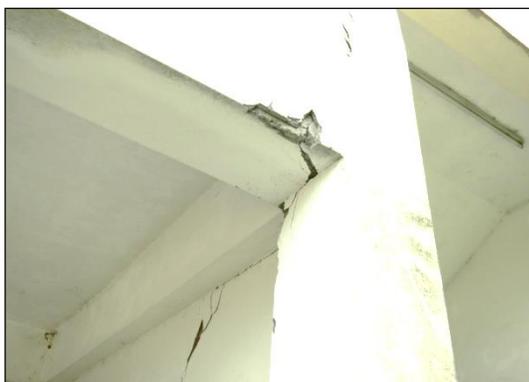
The damage on RC beams due to 2015 Ranau earthquake is presented by Figure 3. It can be clearly observed that the beams only experienced hairline crack which is classified as minor damage. Only some beams experienced spalling of plaster finishing without flexural cracks on its core structure. Most damage occurred on RC beams located at first storey of the building, especially the beams without brick wall beneath it. In other word, the damage occurred on beams which has large opening at its bottom part. This is associated with architectural requirement which is to provide wide space at bottom storey of the building as car park area. Based on in-situ field observation, the cracks were occurred near the beam-column which is also known as critical region. Insufficient steel reinforcement in the critical region of beam may contribute to this damage.

Figure 3: Damages on RC beams due to 2015 Ranau earthquake

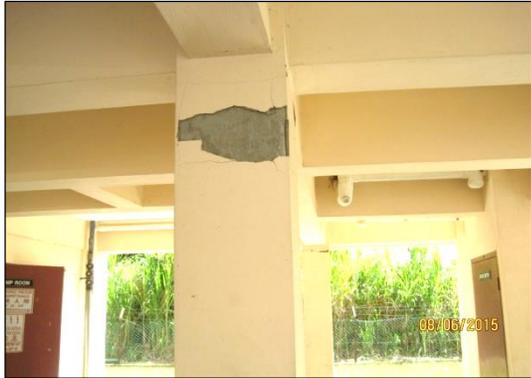
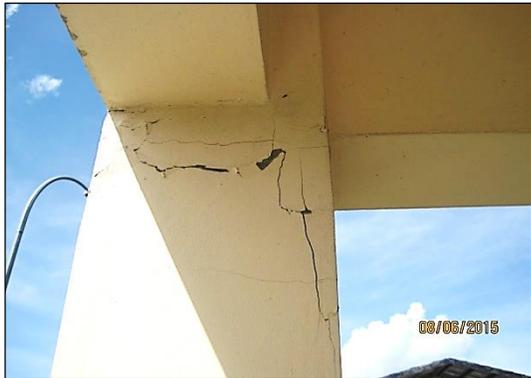
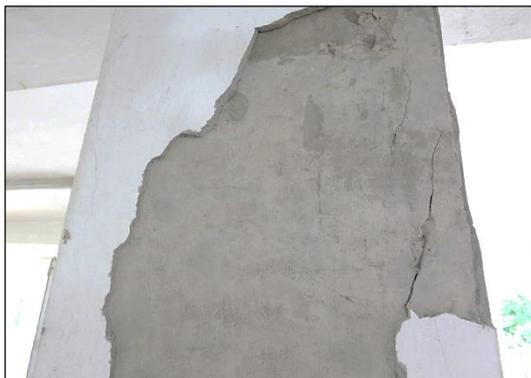
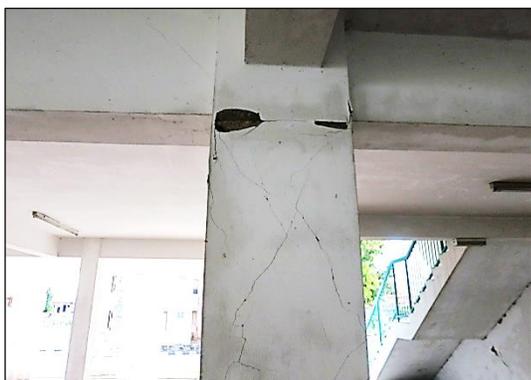
Based on visual observation during the in-situ field investigation, damage occurred on columns seem to be greater than beams. The damage of columns can be classified into three different levels. The first level is just minor damage where the hairline crack and spalling of plaster finishing occurred on columns as shown in Figure 4. The hairline cracks and spalling of plaster finishing mostly occurred at the top part of the columns, which is near the beam-column joint. The concrete cover and core of the columns is still in good condition.

Figure 4: Minor damages on RC columns due to 2015 Ranau earthquake

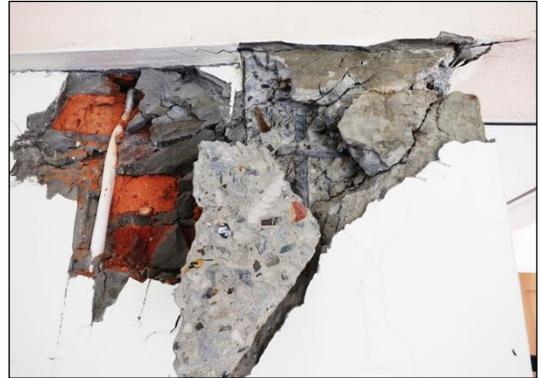
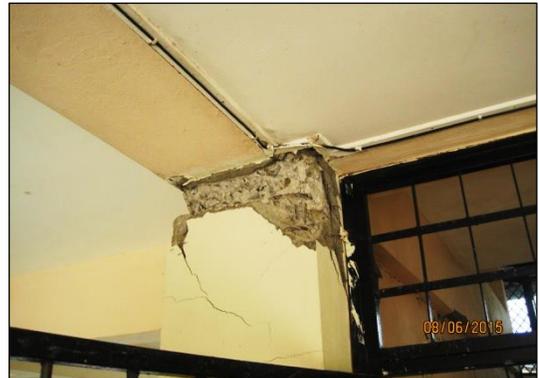
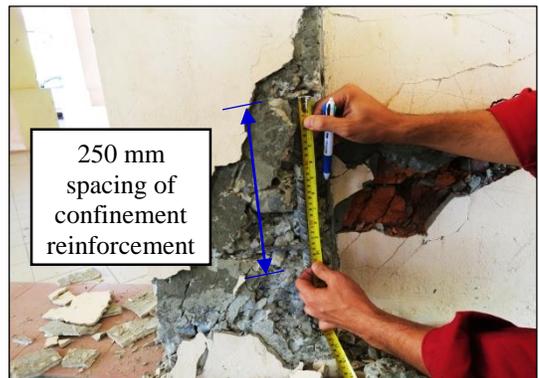
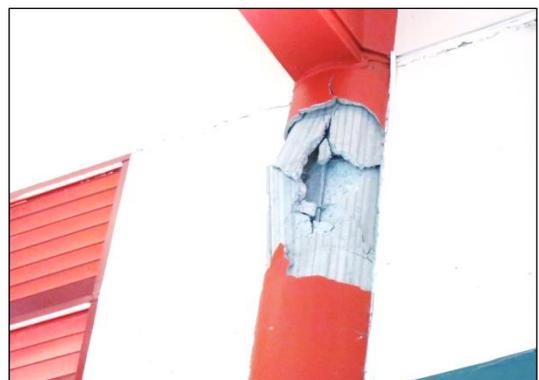
The second level is associated with significant damage where wider cracks and spalling of concrete cover occurred as shown in Figure 5. As a result, the longitudinal and transverse column reinforcement can be seen. The damages also occurred in the critical regions, which is located at the top and bottom part of the columns. This level of damage is associated with LS performance level, where the interstorey drift ratio is equal to 2% (FEMA 356, 2000). Based on quick observation, it seems that the spacing of confinement or transverse reinforcement within the column's critical region is not sufficient to resist earthquake load. One of the inspected columns has 250 mm spacing of confinement reinforcement. For gravity load design this spacing might be adequate. However, if seismic detailing is considered the maximum spacing of confinement reinforcement in column's critical regions with DCM shall not exceed 175 mm (Eurocode 8, 2004).

Figure 5: Significant damages on RC columns due to 2015 Ranau earthquake

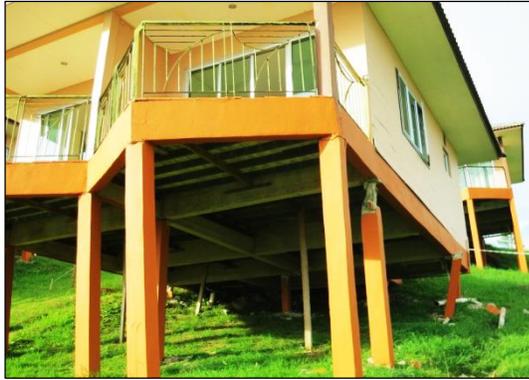
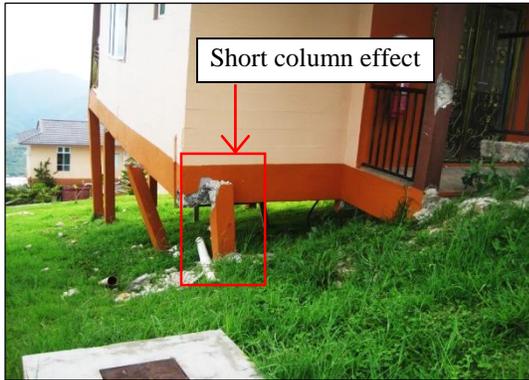
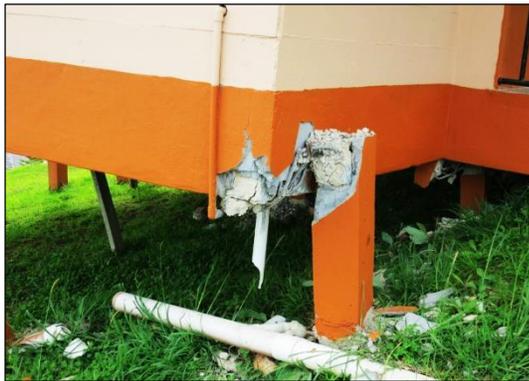
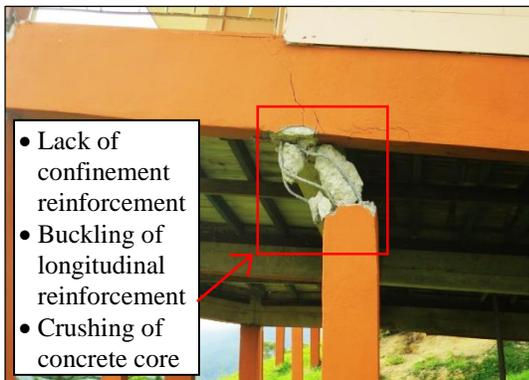
Finally, the third level can be classified as total damage. At this level the columns were totally broken as shown in Figure 6. The square RC columns originally stand for a single storey residential building built on slope. This condition created soft storey mechanism. In addition, the short column effect also occurred because the height of every column are differ to each other. Due to earthquake action the columns were dislocated from its original position even fully separated from the beam. Lack of confinement reinforcement was observed in the column's critical regions. The columns experienced spalling of concrete cover, buckling of longitudinal reinforcement, and crushing of concrete core.

Figure 6: Total damage on RC columns due to 2015 Ranau earthquake

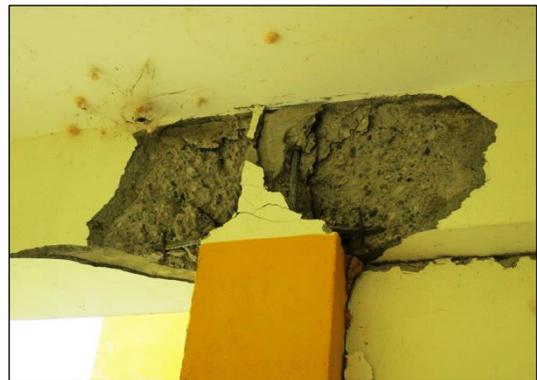
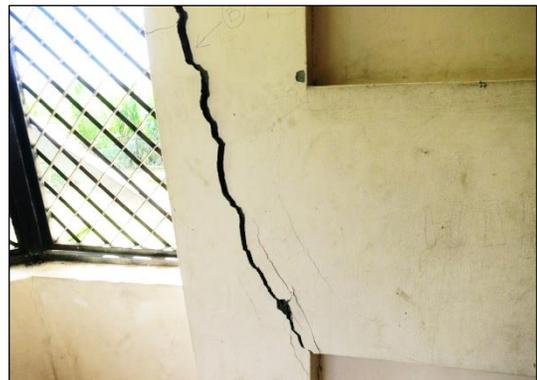
The M_w 5.9 Ranau earthquake also caused damage on the RC beam-column joints as shown in Figure 7. The damages can be classified as significant where severe crack and spalling of concrete cover were occurred. Based on visual field observation, there is no confinement reinforcement within the beam-column joints. Since the inspected buildings were designed for gravity load only this practice is acceptable. However, when it comes to seismic detailing, these beam-column joints did not comply with the seismic provision like Eurocode 8 (2004). In some case, severe crack which originally occurred at the beam-column joints elongated to the critical regions of the columns due to cyclic action of earthquake. This condition caused permanent displacement and the column has no more strength to resist any lateral load caused by after-shocks.

Figure 7: Damage on RC beam-column joints due to 2015 Ranau earthquake
