# International Journal of Civil Engineering and Geo-Environment

## CASE STUDY: POST DISASTER INVESTIGATION ON WIND DAMAGE FOR RURAL HOUSING ROOFING SYSTEM IN NORTHERN PENINSULAR MALAYSIA

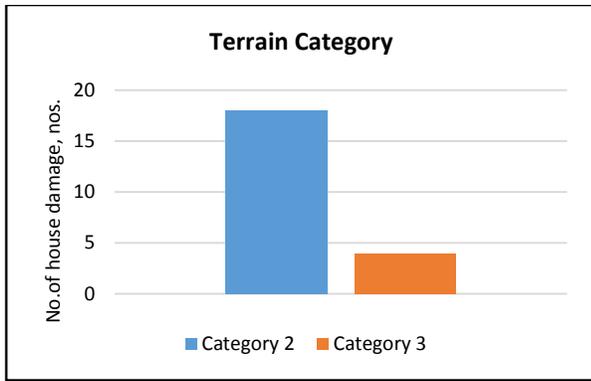
Figure 1: Terrain category

Referring to Figure 1, it is shown that houses located in terrain category type 2 frequently hit by the windstorm. According to MS1553:2000, terrain category 2 describes water surface, open terrain, grassland with few well scattered obstruction having height generally from 1.5 m to 10.0 m. In contrast, terrain category 3 refers to terrain with numerous closely spaced obstructions 3 m to 5 m height such as areas of suburban housing. There was twenty one (21) numbers of rural roofing houses damage in the windstorm event located in terrain category 2. Meanwhile, only 11 number of houses located in terrain category 3 involved in the event. Observation shown that most probably house surrounded by vacant area prone to have great impact in windstorm event. These vacant area in this research context is referring to paddy field and grassland and least obstruction.

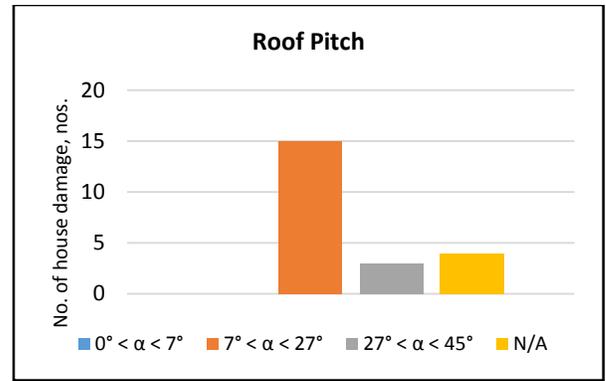
Figure 4: Roof pitch

It was shown in Figure 4, there are 15 number of house approximately constructed with the roof pitch between  $7^\circ < \alpha < 27^\circ$ . None of rural house observed has steep roof pitch which is less than  $7^\circ$  ( $\alpha < 7^\circ$ ). Previous scholar highlight that roof pitch less than  $22^\circ$  ( $< 22^\circ$ ) is susceptible to wind damage. This research finding was in line with previous scholar that rural housing roofing damage due to low pitch. This leads to strong uplift force form outside the house. The principles of typhoon-resistant construction suggested to build the roof angle at an angle of  $30^\circ$  to  $45^\circ$  by (Ahmed, 2011).

Build the roof angle at an angle of 30° to 45° decrease wind damage impact. Further collaboration among consultant, contractor or homebuilder is very helpful to ensure that the roof pitch for rural roofing is design and constructed accordingly at site. Otherwise, severe damage was observed to roof and loss of roof sheathing. This damage involved other non-structural elements such as purlin and rafter. Rafter to purlin connection must be secured tightly to minimize the damage risk. Output from this study provides basic idea for the design improvement need to be taken place based on the existing guideline and code of practice.

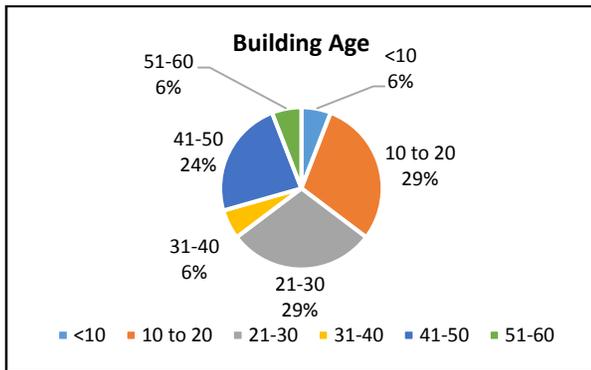
Figure 2: Building age

As illustrated in Figure 2 shows the range of house built age identified was from 13 to 55 years. These findings shows that damage house occurred majority involved housing more than 20 years constructed. Building age range from 10 to 20 years and 21 to 30 years shown the dominant building age represent 29% number of total house damage. Subsequently, this one of the factor shall be taken into consideration contribute towards the wind disaster impact. (Goyal et al., 2012) described the house age less than 10 years is new. It was shown that the least number of damage in the windstorm involving only 6% of total house for age constructed less than 10 years. However, the least damage also observed on rural house constructed age more than 51 years at 6%. This result indicate that small number of house existence also at 6% with built age more than 51 years old in the rural area.

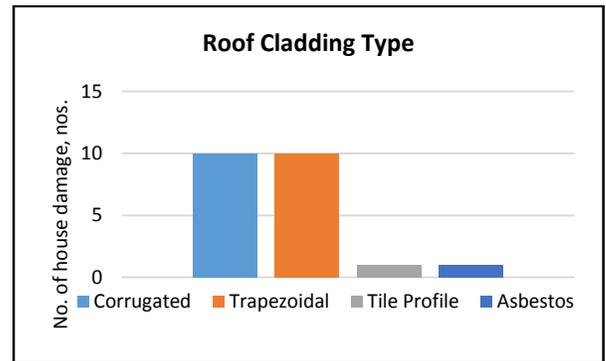
Figure 5: Roof cladding type

As shown in Figure 5, roofing cladding type frequent used for rural house is metal deck which is corrugated and trapezoidal, asbestos and tile profile. From the observation, metal deck corrugated type is the most preferred cladding in the rural roofing system among the homebuilder. These may due to material used for cladding is substandard, poor installation and workmanship, connection failure between cladding and purlin. Common occurrence observed is loss of cladding during windstorm event.

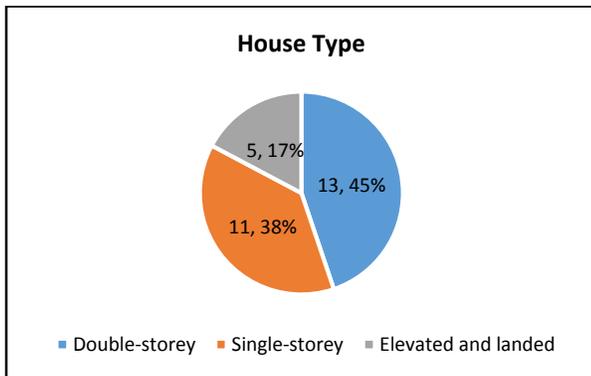
Figure 3: House type

There are three types of rural house built within these study area involved in the windstorm event as shown in Figure 3. The house type observed was double-storey landed, single-storey; and elevated and landed. The common construction material use for the house is concrete or in combination of concrete and wood. Generally, it was observed the double-storey house and elevated and landed house was made of combination of concrete and wood rather than single-storey house only constructed from concrete and masonry. The total numbers of 29 of rural house observed during post-wind disaster visit. Majority windstorm damage prone to double-storey landed house which is about 13 numbers of house (45%) in this case study. Hence, followed by the single-storey house involved 11 number of house (38%) most probably the

second highest house ranked type impacted by the windstorm followed by elevated and landed house shown 5 damage houses represent 17%.

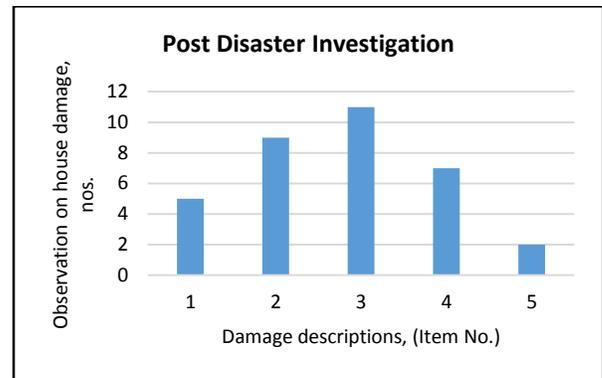
**Figure 6:** Wind impacted rural roofing damage

1. Edge of the cladding is the risky part on the roof structure to lift off and damage. This damage can be considered as only light damage.
2. Partially damage of roof cladding and can be considered as light damage.
3. Severe damage to roof and loss of roof cladding. This damage involved other non-structural elements such as purlin and rafter.
4. Lost all the roof cladding.
5. Loss of roof structure.

It was identified most common problem due to windstorm was severe damage to roof and caused loss to roof cladding. This damage also involve purlin and rafter the non-load bearing member elements. Consequent damage observed was loss of roof structure. Least loss of roof structure experienced and these can be considered as minimal structural damage on post disaster investigation. Meanwhile, others damage observed was roof partly uncovered and these can best referred as light damage. From the observation, damage occurred at the corner of roof structure also considered as light damage and ranked second lowest structural damage compared to top five listed damage from the illustrated graph in Figure 6.

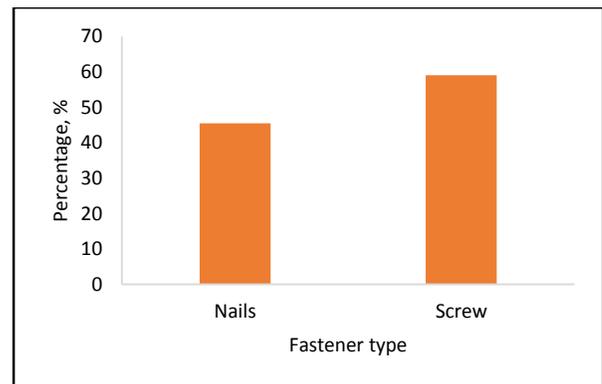
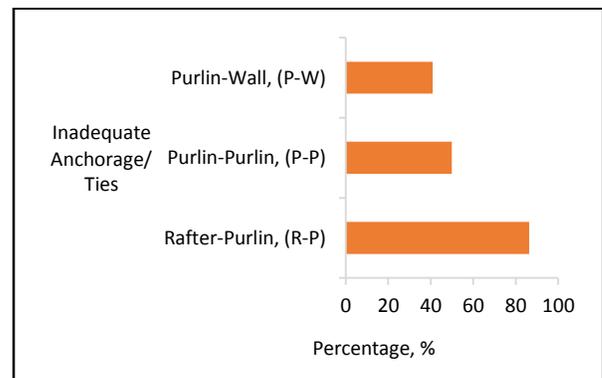
Most of the damage to actual roofs is caused by local high suction and large pressure fluctuations. Referring to Figure 7 and Figure 8, site observations are made for fastener failure based on two major aspects, namely, screw and nails, and location of connection. Location of connection is divided into three categories, that is, rafter to purlin (R-P), purlin to purlin (P-P), and Purlin to wall (P-W). Screw gives significant values at 59% failures compared to nail at only 50% failures. This is a very good finding whereby local homebuilder utilized screw understood that this fastener riveted performed better than nail at rural roofing system based on their previous experience. Observation made at all affected rural roofing damage concluded inadequate anchorage or ties probably occurred at location between rafter and purlin at 86% and the lowest at purlin to wall at 41%. Probability the connection failure between purlin to purlin is moderate, at 50%. The result indicates that roof damage is probably influenced by failure of fasteners which is screw and inadequate anchorage or ties of roofing located at rafter to purlin.

The common mistakes that contribute to the failure of the roofing system are due to poor workmanship by carpenters, poor installment of the fasteners and joint, and substandard roofing materials, such as fasteners used (i.e., screw and nails, roof sheathing, trusses, and purlins). Timber house weakness is on proper connection detailing. This has often led to tremendous disaster impact .
