MODELING OF STRUCTURAL DEFORMATION OF STAFF QUARTERS HOSPITAL RANAU SUBJECTED TO THE 2015 RANAU EARTHQUAKE USING RUAUMOKO 2D

A.G. Kay Dora^{1*}, T. Mohd Azuan¹, I. Izzaidah¹

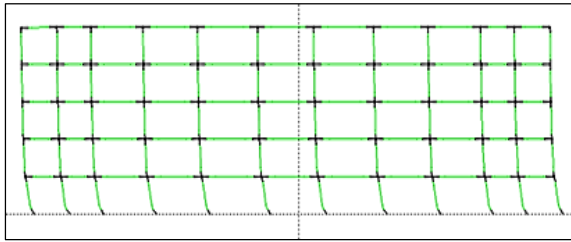
Figure 5: Modeled Deformation of the Prototype Building

The result from Ruaumoko2D programming shows the structural deformation of the prototype building during earthquake as shown in Figure 5. Table 2 shows the maximum lateral displacement of every level and the time of maximum displacement take placed where maximum lateral displacement occurred at 5% damping ratio. As shown in Table 2, the lateral displacement is higher when floor level of a building is increase. Deformation capacity is reasonably high where axial force or strength is low, while at lower floor, deformation is hard to occur because of the present high axial load.

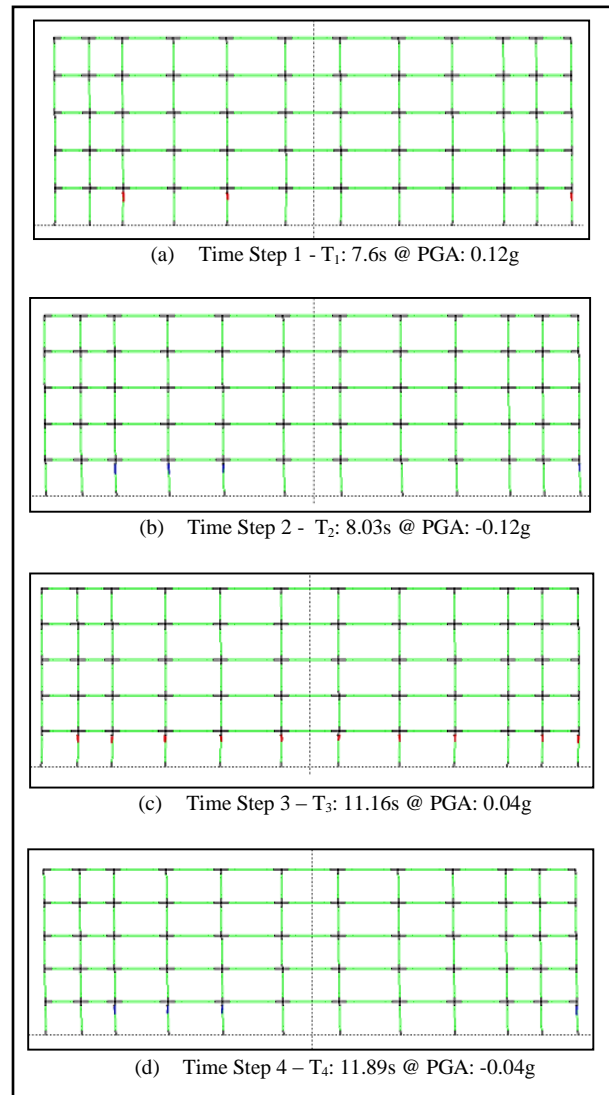
Figure 7: Structural Deformation of the Prototype Building under the 2015 Ranau Earthquake Record at various Time History

Figure 6 shows excitation versus time for the 2015 Ranau Earthquake record. The Peak Ground Acceleration (PGA) 0.12g happened at 7.6 seconds during the 2015 Ranau Earthquake. Figure 7 shows the structural deformation for the prototype building under the 2015 Ranau Earthquake at four selected time history modeled using Dynaplot program. From the modeling, at time step 1 with PGA=0.12g which occurred at 7.6 seconds of time history, the yield condition of the beam-column joints was shown at the first floor level. The beam-column joints yielded in tension moments and are marked with red color in the beams and the columns. The damages were identified at the corners and interior beam-column joints at the first floor of the prototype building. Meanwhile, a plastic hinge was formed with compression moment (marked with blue color) were detected at columns at the first floor of the prototype building at time step 2 (PGA=-0.12g) which was observed at 8.02 seconds time history, more structural damage occurred at the beam-column joint. At time step 3 ($T_3 = 11.16s$) with PGA=0.04g, severe damage (marked in red color) occurred at almost all columns at the first floor. Finally, at time step 4 ($T_4 = 11.89s$) with PGA=-0.04g, the failure of the column in compression was also observed at the first floor, indicated by the blue color. The modeling results are to be verified with the real damages on-site which is presented in the next sub-section.
