SEISMIC ASSESSMENT OF STAFF QUARTERS HOSPITAL RANAU SUBJECTED TO 2015 RANAU EARTHQUAKE USING FRAGILITY CURVE

T. Mohd Azuan¹, A.G. Kay Dora^{1*}, R. Norazila¹

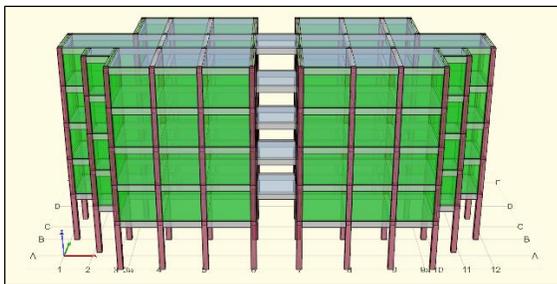
Figure 1: 3D Modeling of the Prototype Building

In this study, the building analysis of staff quarters Hospital Ranau was carried out using Orion R18 software program. The analysis was carried out to get static load analysis such as mass node, element and other parameter. These parameters were used as an input data in Ruaumoko 2D program. Figure 1 shows the model of prototype building.

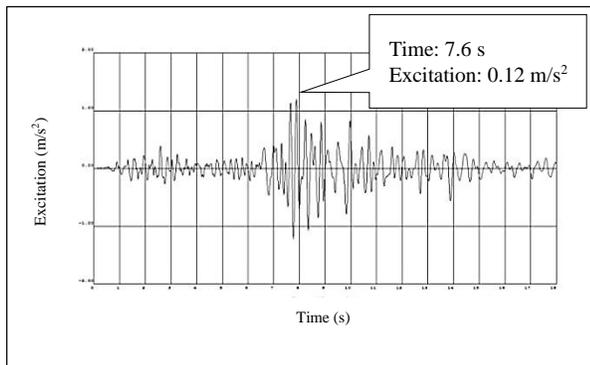
Figure 2: Excitation versus Time for 2015 Ranau Earthquake

Modeling of staff quarters Hospital Ranau using Ruaumoko 2D program gives out the excitation versus time graph for the structure that shows acceleration of the structure subjected to peak ground acceleration of 0.12g. As shown in Figure 2, the acceleration is high around 6 second to 11 second excitation. The maximum value of acceleration is 7.6 second with excitation 0.12 m/s².

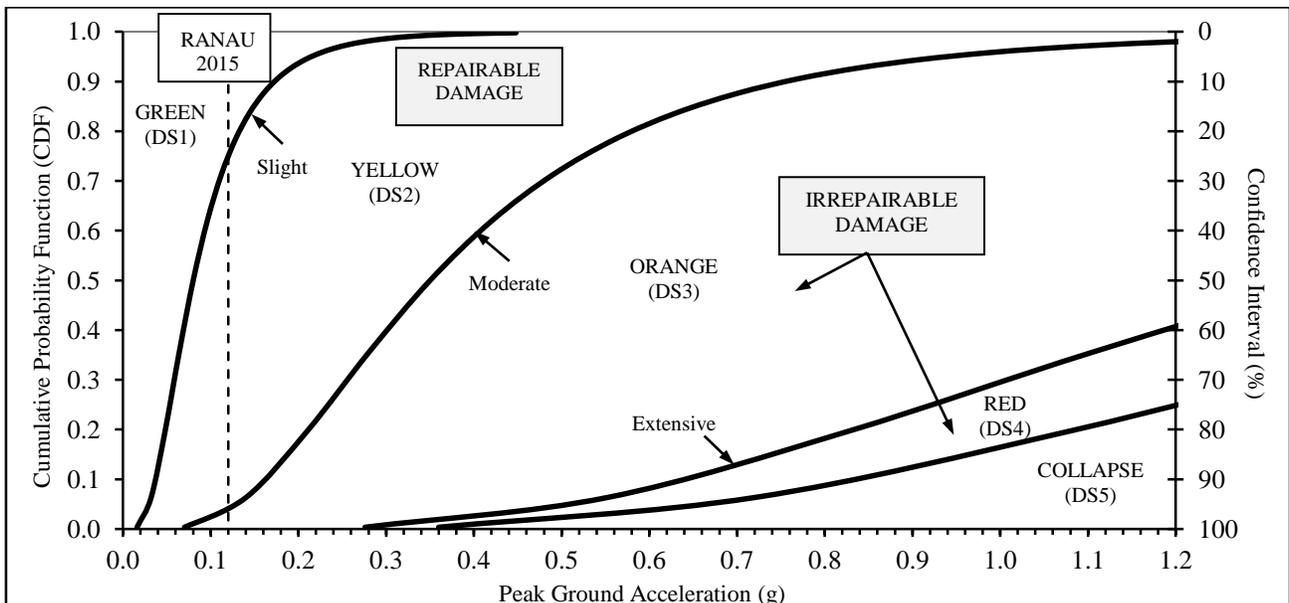
Figure 3: Fragility Curves for the Staff Quarters Hospital Ranau

0.08. Meanwhile, yellow color-coding was tagged with displacement ductility of 0.35, which means an immediate occupancy performance level (DS2). Yellow color-coding describes slight structural damage with small cracks in columns and beams; hence the building can be entered to remove belongings. The orange (DS4) and red (DS5) color-codings were categorized as life safety and collapse prevention, respectively. Orange color-coding describes moderate structural damage which leads to buckling of reinforcement; meanwhile red color-coding describes large cracks in structural elements leading to near-collapse of the building. For the building, both orange and red color-codings were expected to have displacement ductility values of 1.38 and 1.80, respectively. Table 9 was used to produce the fragility curve for the building. Figure 3 shows the fragility curve which was developed for the Staff Quarters Hospital Ranau using Equations 1 and Equation 2. The fragility curves were shown by the black continuous lines. In the fragility curve, the excitation was based on the PGA 0.12g which happened during the 2015 Ranau Earthquake. It is denoted as the dotted vertical lines which predicted the confidence interval (CI) percentage. Under PGA of 0.12g, the percentage of CI was 26% under the green color-tag and 69% chance of slight damage (yellow color-tag) to the structure. However, the joint has 5% CI under orange color-tag and would suffer moderate structural damages and also buckling of reinforcement bars. The CI values exhibited that the Staff Quarters Hospital Ranau would still have higher chances to sustain under immediate occupancy (yellow color-tag) when subjected to

PGA = 0.12 g. The building would still safe for occupancy and suffers slight damage.

From the analysis of Ruaumoko2D and Dynaplot Program, Level 1 is the most critical part of Staff Quarters Hospital Ranau when subjected to the 2015 Ranau Earthquake. This concluded that the soft-storey building would experience damage at lower floor. This is proved by on-site observation which showed moderate damages at beam-column joint area at Level 1 during the earthquake. However, based on the fragility curve analysis, the building would still safe for occupancy and suffers slight damage. In other words, the building still have chanced to be repaired and strengthened using an appropriate retrofiting method, so that it can be reoccupied after three to six months of retrofiting.
