# International Journal of Civil Engineering and Geo-Environmental

## BUILDING INVENTORY FOR SEISMIC RISK ASSESSMENT USING UNMANNED AERIAL VEHICLE

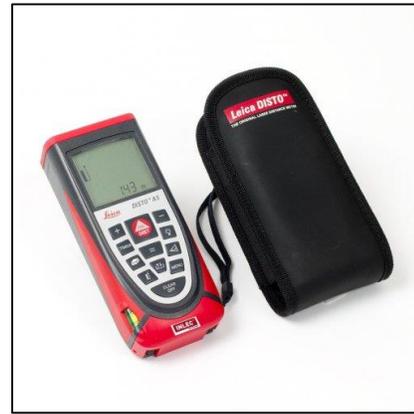
Figure 2: Leica Disto A5.

The case studies for this research study were picked among the buildings in the compound area of Universiti Teknologi Malaysia, Johor. In order to achieve a more effective result, different types of building are chosen in order to have varies result data in making this research study more efficient. Before performing the UAV procedure in data collection, a site investigation is done in order to obtain the actual dimensions of the buildings involved as the case study. The operation of measuring the dimensions was done with a Leica Disto A5 distance measuring tool which has a laser rangefinder tool in order get the dimensions. Figure 2 shows the Leica Disto A5.

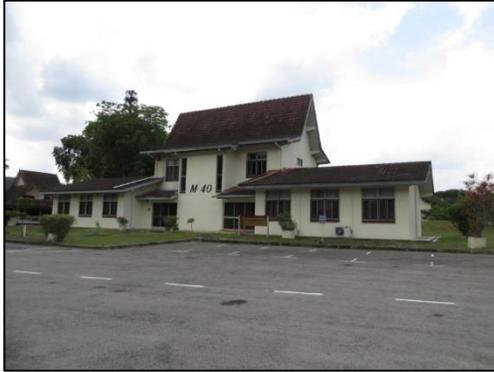
**Figure 3:** Case Study 1 - Building Block M40

After analysing and performing brief study, 3 buildings are chosen as the case study of this study in order to comply with the objectives. The case studies that are chosen are from different dimensions and purposes. The first case study is Case Study 1 as shown in Figure 3 which is a building block M40 of Tun Dr. Ismail College. The building is a two-stories building that are used as an office for the “Pertubuhan Juruukur Diraja Malaysia” for the Johor region.

Dimension	Case Study Buildings		
	1	2	3
Height (m)	6.196	24.152	3.655
Width (m)	12.15	45.901	8.065
Length (m)	17.501	75.371	12.578

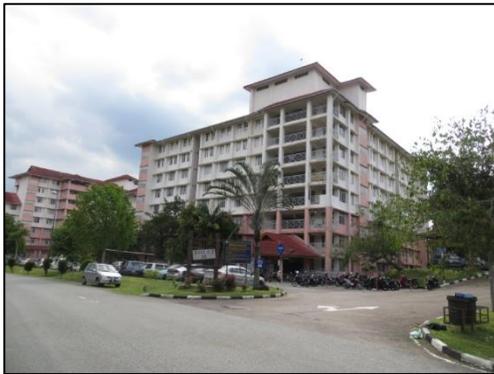
**Figure 4:** Case Study 2 - Student Residential Apartment

The following case study is Case Study 2 which is a 7-stories tall building as shown in Figure 4. The building is located at Dato’ Onn Jaafar College which it is the student residential apartment College 16 block XC A.

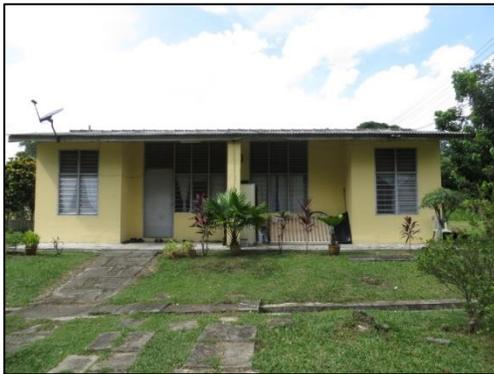
**Figure 5:** Case Study 3 - Staff's Houses

The final case study is Case Study 3 which is shown as Figure 5 which is the staff’s houses near the Tun Razak College. Four blocks of houses are captured as the case study. The houses are one-story. Table 1 shows the on-site measured dimensions of the case study buildings.

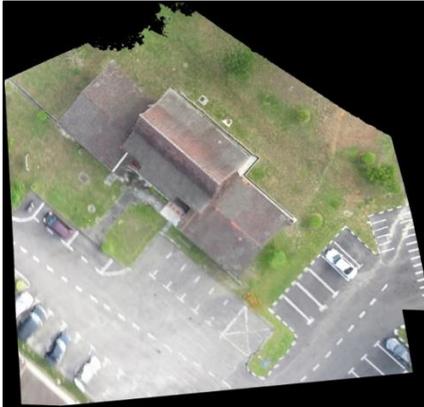
**Figure 7:** Orthophoto / Plan View

After completed all the procedure, results from the analysis can be printed out in order to perform a more detailed study and apply the result for objective purposes as shown in Figures 7, 8 and 9. Project must be first save into hard drive in order to observe for future work. Results that can be printed out are Model where the 3D model that is reconstructed can be exported and used. The second result is Orthophoto where the data can be printed out as and JPEG image file or Google KMZ file in which the orthophoto can be mapped into Google Earth Pro. Orthophoto is important as it give the plan image of the buildings. The third result is DEM where the result can be printed in planar view from any direction that is desire. The final result that can be printed is the whole Report which result includes the date of generating the report, Orthophoto, Survey Data, Camera Position and Digital Elevation Model.

Dimensions	Analysis result
Height (m)	7.188
Width (m)	11.719
Length (m)	16.716

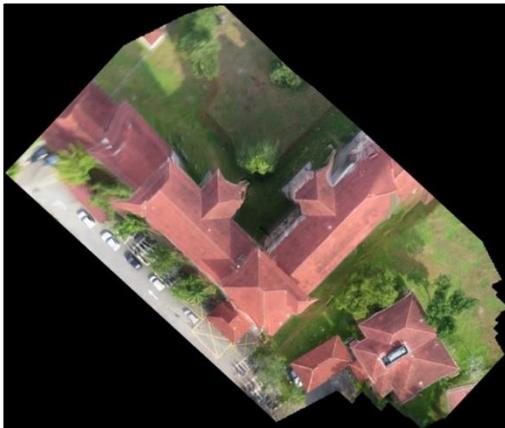
**Figure 8:** Orthophoto / Plan View

Dimensions	Analysis Result
Height (m)	36.512
Width (m)	45.275
Length (m)	74.1507

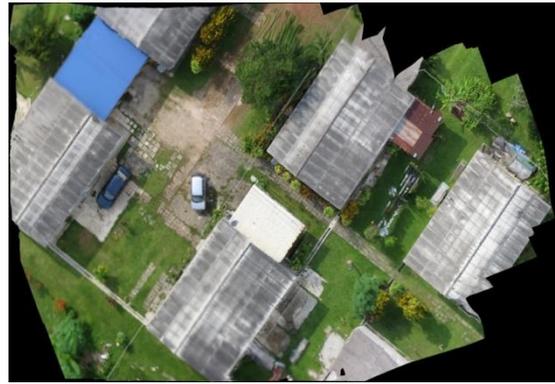
**Figure 9:** Orthophoto / Plan View

Dimensions	Analysis result
Height (m)	2.843
Width (m)	8.159
Length (m)	12.880
