International Journal of Civil Engineering and Geo-Environmental

SEISMIC PERFORMANCE OF INTERIOR WALL-SLAB JOINT IN TUNNEL-FORM BUILDING DESIGNED TO BRITISH STANDARD

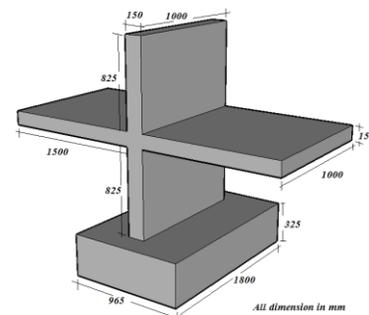
Figure 1: Schematic diagram of Interior Wall-slab joint design to British Standard

The sub-assembly of interior wall-slab connection comprises of foundation, shear wall and slab panels as shown in Figure 1.0. The height of the wall panel is limited to 1500mm while the length of slab panel is 1500 mm measured from the wall surface. All the panels' thickness is 150mm. The length, width and thickness of foundation beam are 1800mm, 965mm, 325mm respectively. This specimen has designed according to BS8110 (1997).

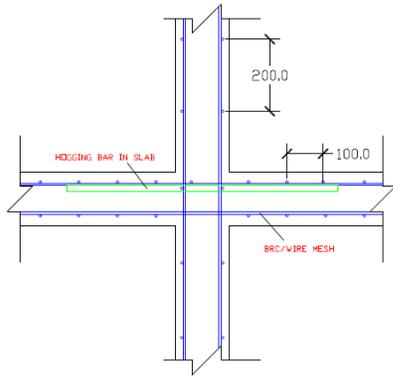
Figure 2: Reinforcement detail of Interior Wall-slab joint (dimension in mm).

Figure 2 shows the reinforcement detail at interior wall-slab joint. Fabric wire mesh (BRC-7) with 200mm by 100mm grid has utilized. The arrangement of the wire mesh in specimen can be seen in this figure. Hogging bars of 12mm diameter have placed 100mm apart in transverse direction to cater negative moment in the slab panels.

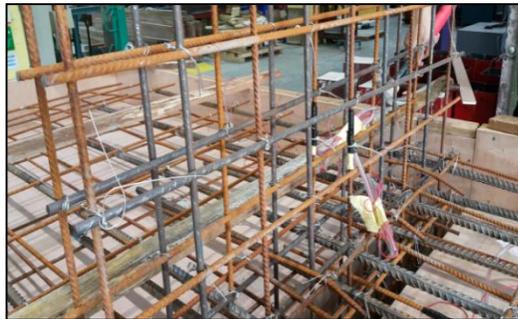
Figure 3: Reinforcement detail of Interior Wall-slab joint

Figure 3.0 and 4.0 show the photo of joint reinforcement and the completed specimen respectively.

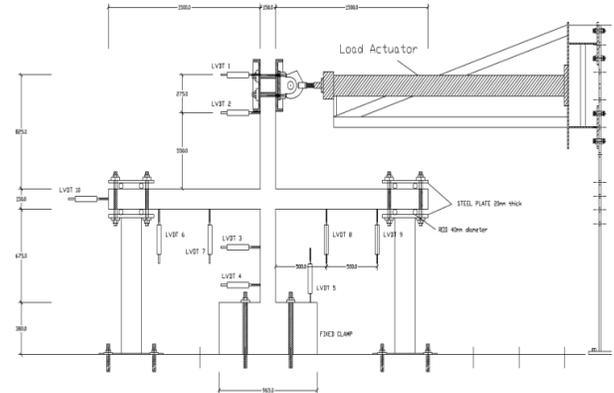
Figure 5: Schematic diagram of Experimental set-up of specimen

Figure 5 shows the systematic arrangement of linear potentiometers and double actuator. The load cell with capacity of 250kN has connected to double actuator and supported by the reaction frame. Double actuator has imposed the lateral cyclic loading on the wall with control displacement. While the head of load cell is connected to steel plate and clamped to the wall by screwed up the treaded bars snug tight.

The RC wall became sandwiched by steel plate clamping to the double actuator head so that the wall can be pushed and pulled laterally during the experiment. At the of end floor slab, two steel plates are attached to wall using high yield threaded rods. The slab is supported by UB steel section to ensure that the support is fixed and the wall is free to rotate in-plane. The foundation beam has clamped to strong floor by penetrating the high yield threaded bar through the holes located in foundation beam. A total number of 10 LVDT have installed on the specimen in order to record the deflection consequential from the lateral cyclic load applied on the sample. Five units of LVDT have installed horizontally along the height of wall while another five units along the slab span and foundation as depicted in Figure 5..

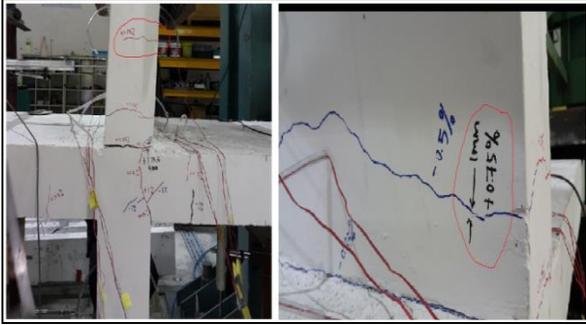
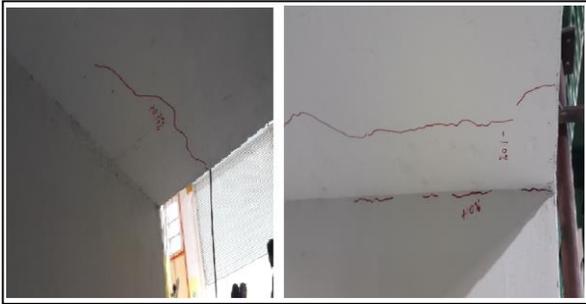
Figure 9: Visual observation of cracks propagated on specimen within 0.75% to 1.0% drift level

(b) Upper wall panel

(c) Slab panel surface

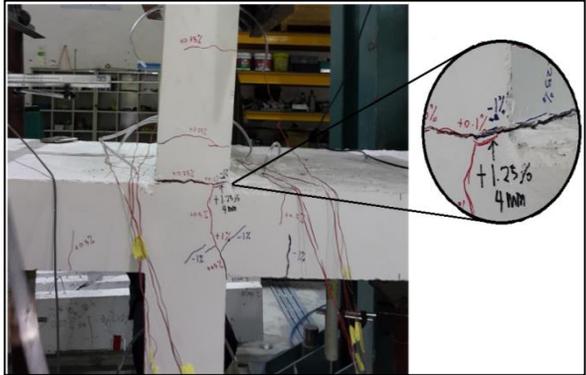
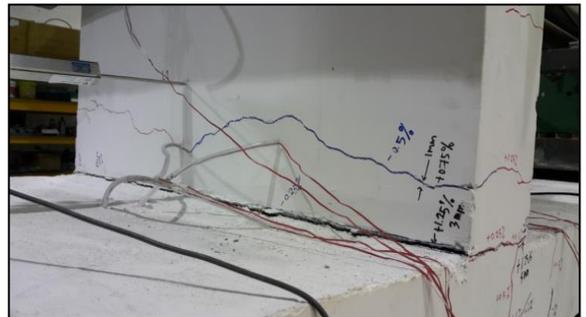
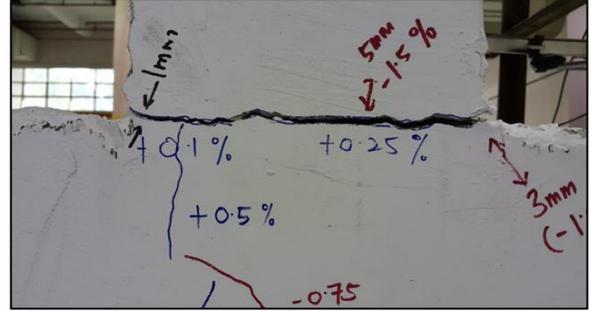
Figure 10: Visual observation of cracks propagated on specimen within 1.25% to 1.5% drift level

(a) Wall-slab joint

(b) Wall-slab joint viewed from side

(c) Fracturing of upper wall panel

- 1) Approximately, the joint has yielded at 0.25% drift and reached the ultimate state at 0.75% drift. Beyond 0.75% drift, the joint has failed and ultimately fractured at 1.5%.
- 2) The calculated displacement ductility for specimen was less than 3 and it is classified as Ductility Class Low (DCL) as stated in Eurocode 8.
- 3) Insufficient reinforcement provided in the interior wall-slab joint consequent low ductility that lead to brittle failure modes of the joint.
- 4) The BS8110 code is no longer realistic to be adopted in designing the tunnel form building based on the current seismic demand in Malaysia.

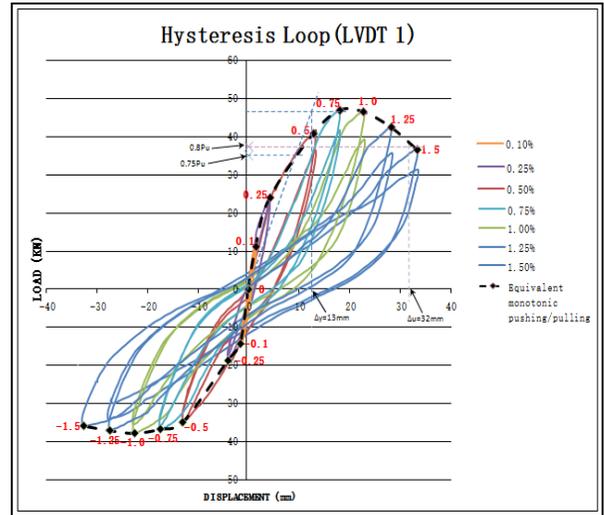
Figure 11: Hysteresis loop at LVDT 1.

Figure 11 illustrates the hysteresis loop of the specimen at LVDT 1 that has superimposed by the equivalent monotonic pushing/pulling load-displacement response. This has signified that the dynamic response of wall-slab joint is resembled to the static behaviour that commonly encounter in the reinforced concrete structures.

The strength degradation of the joint can be observed clearly in this figure. The ultimate capacity of lateral resistance of the specimen is 46.9 kN at 0.75% drift. The joint behaved elastically up to 0.25% drift. Yielding has found to take place on the first cycle to $\pm 0.25\%$ drift at about 24kN lateral force. The ductility factor is defined as the ultimate deformation divided by the corresponding deformation present at the yield point. In this study, the definition of displacement of yield is adopted from Park (1988) and the ultimate displacement can be estimated as that post-peak deformation when the

load drop in strength (commonly taken as 20%) from the peak load or maximum attained strength (Priestley et al., 2007b). Consequently, the ductility, μ capacity of this unit was $32/13=2.5$. The accepted range of ductility which had been specified in Eurocode 8 is 3 to 6 for Ductility Class Medium (DCM). The calculated displacement ductility for specimen was less than 3 and it is classified as Ductility Class Low (DCL) as stated in Eurocode 8 (EN1998). Consequently, the interior wall-slab joint designed according to BS 8110 will not survive under moderate to strong earthquake events.
